# **INDOOR AIR QUALITY ASSESSMENT**

**Hosmer Elementary School  
1 Concord Road  
Watertown, Massachusetts**

Prepared by:  
Massachusetts Department of Public Health  
Bureau of Environmental Health Assessment  
January, 2002

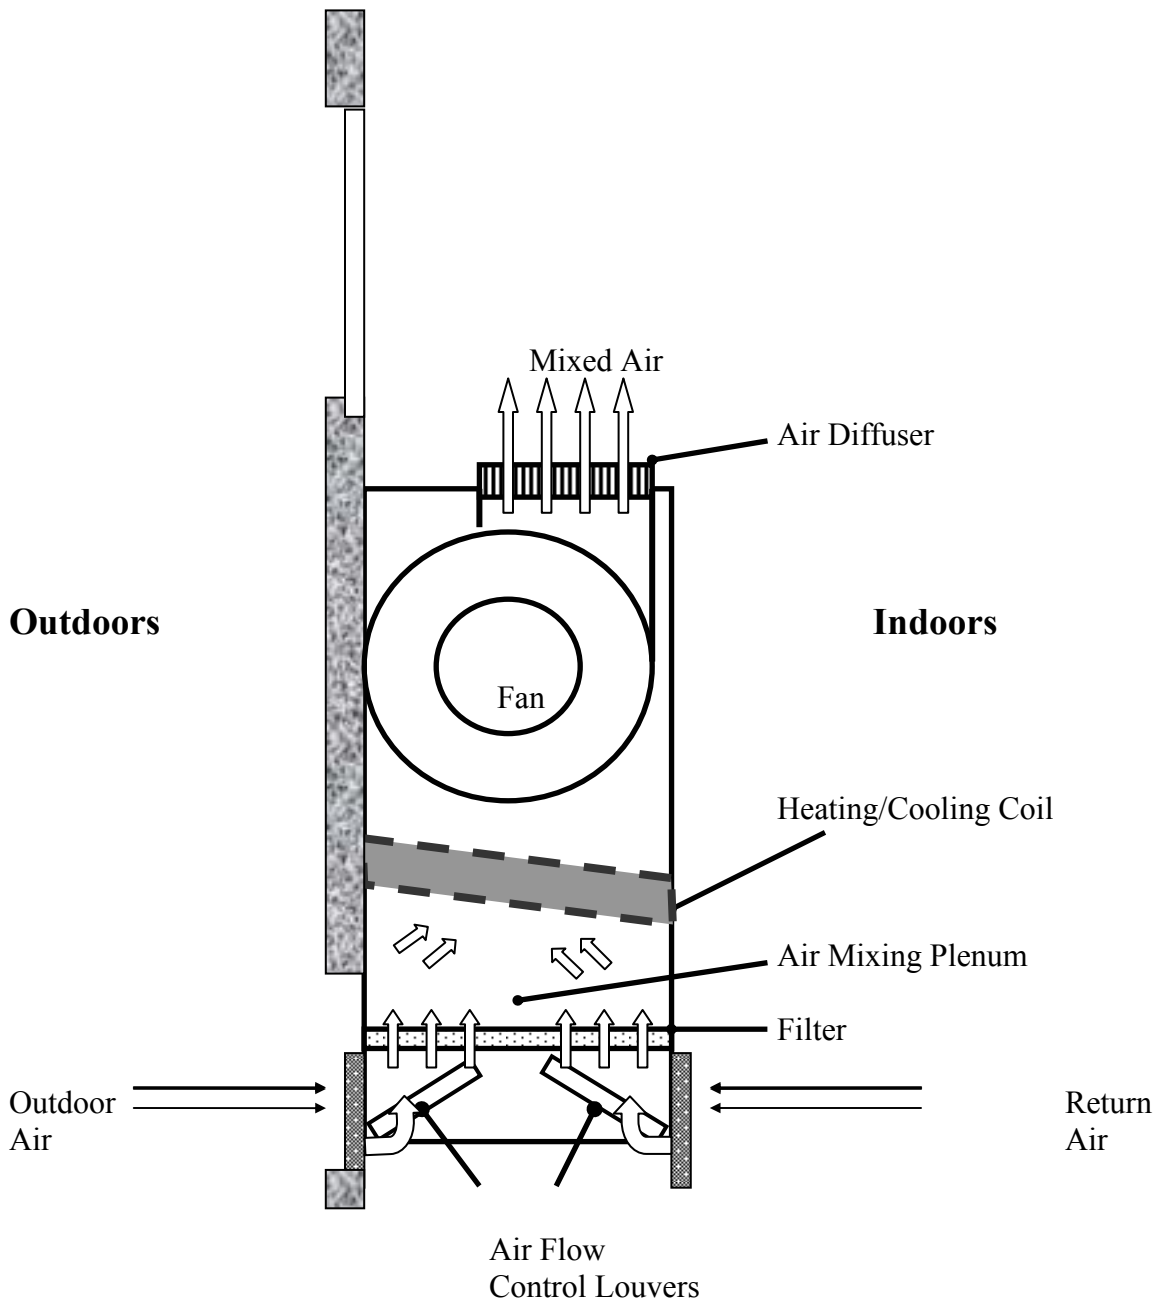
**Figure 1**

Fresh air in classrooms is supplied by a unit ventilator (univent) system (see Picture 1). Univents draw air from outdoors through a fresh air intake located on the exterior walls of the building and return air through an air intake located at the base of

each unit (see [Figure 1](#)). Fresh air and return air are mixed, filtered, heated and provided to classrooms through a fresh air diffuser located in the top of the unit. Univents in classrooms 7, 9, 11 and 13 were not operating during the assessment, which can indicate a mechanical problem or deactivation. Obstructions to airflow were also seen in a number of classrooms (see Picture 2). These included books, papers and posters on top of univents, as well as bookcases, tables and desks in front of univent returns. To function as designed, univent fresh air diffusers and return vents must remain free of obstructions. It is important that univents be activated and allowed to operate during school hours.

**Unit Ventilator (Univent)**

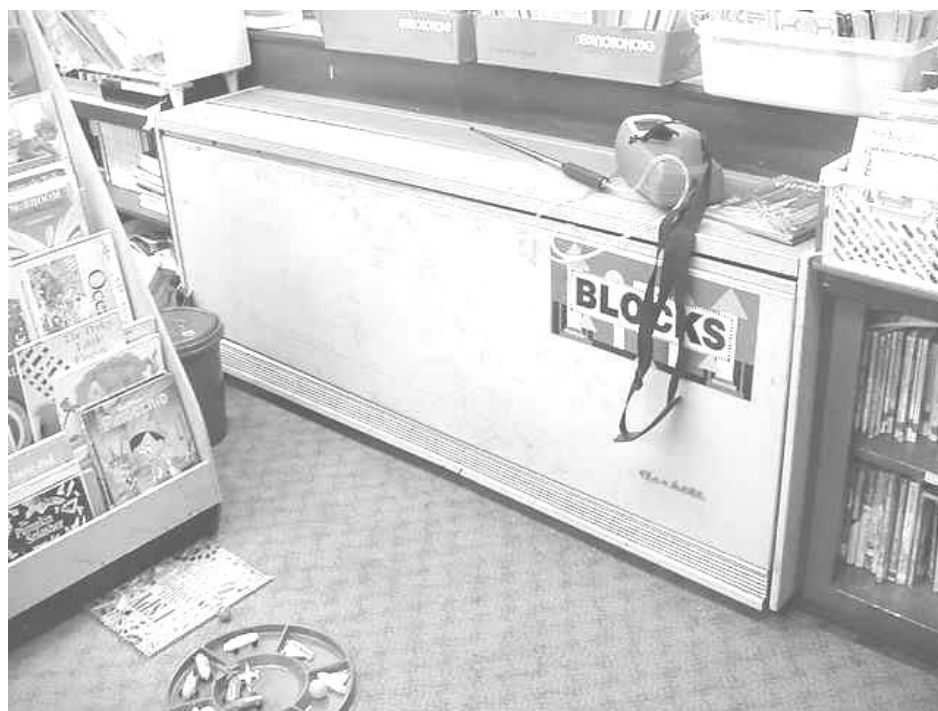
**Picture 1**

**Classroom Unit Ventilator (Univent)**

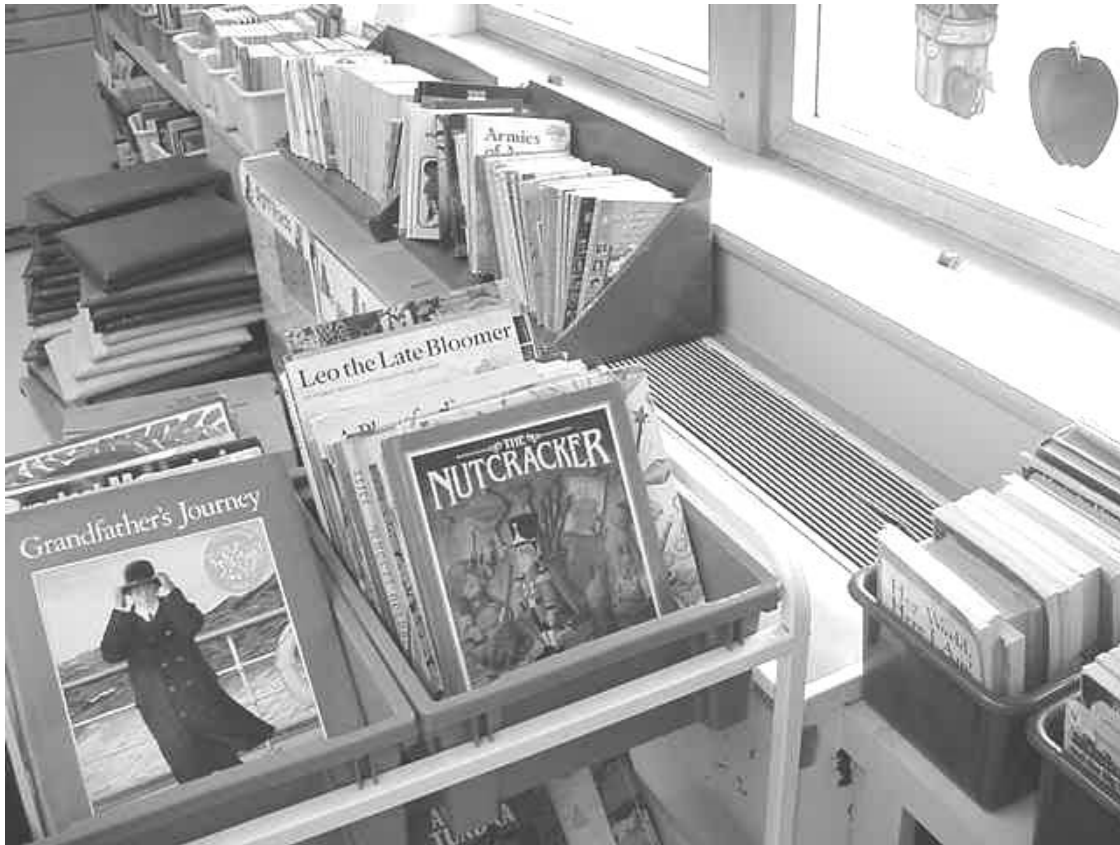
**Picture 2**

**Classroom Univent Obstructed by Various Items**

3. To maximize air exchange, the BEHA recommends that both supply and exhaust ventilation operate continuously during periods of school occupancy.
4. Remove all blockages from univents and exhaust vents to ensure adequate airflow. Close classroom hallway doors to maximize exhaust ventilation.

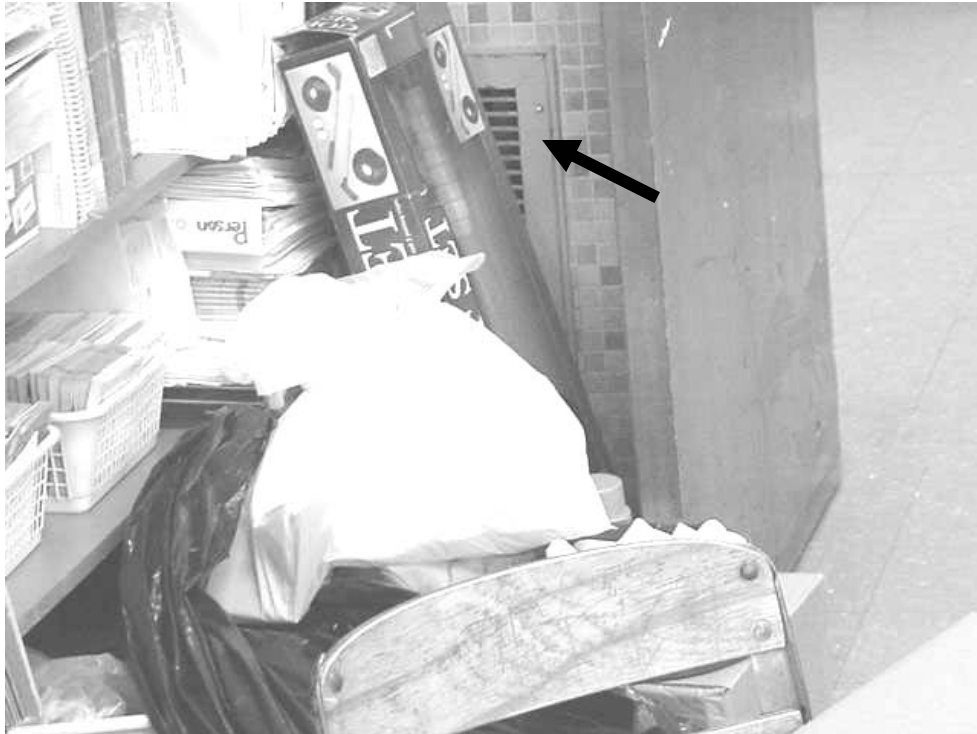
**Picture 3**

The mechanical exhaust ventilation system in classrooms consists of grated, wall-mounted vents. Exhaust vents were not functioning in classrooms 9, 11 and 13 during the assessment, which can indicate either a mechanical problem or deactivation. The exhaust vent in classroom 207 was missing its grate. A number of exhaust vents were obstructed by tables, chairs, boxes and other items (see Picture 3). The location of exhaust vents can also limit exhaust efficiency when the classroom hallway door is open. When a classroom door is open, exhaust vents will tend to draw air from both the hallway and the classroom (see Picture 3). The open hallway door reduces the effectiveness of an operating exhaust vent to remove common environmental pollutants from classrooms. Without removal by the exhaust ventilation, normally occurring environmental pollutants can build up and lead to indoor air complaints.

**Obstructed Classroom Exhaust Vent, Also Note Open Door**

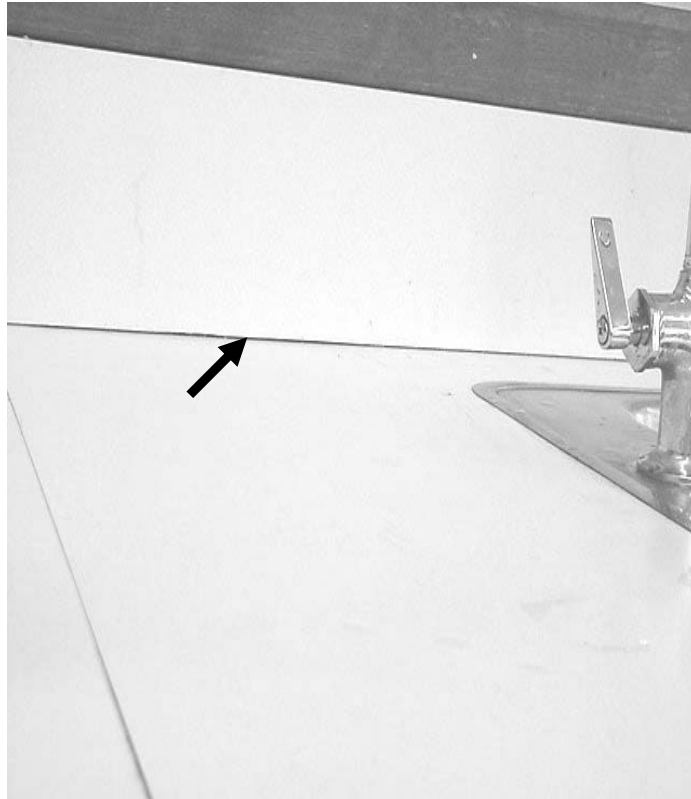
**Picture 4**

Spaces between the sink countertop and backsplash were noted in several classrooms (see Picture 4). Improper sink drainage or overflow could lead to water penetration of countertop wood, the cabinet interior and behind cabinets. Like other porous materials, if these materials become wet repeatedly they can provide a medium for mold growth, which is difficult to clean and can be irritating to sensitive individuals. These countertops are scheduled for replacement during subsequent renovations.

**Space between Sink Countertop and Backsplash**

6. Continue with plans to replace sink countertops during subsequent renovations.  
If not replaced, seal areas around sink to prevent water-damage to the interior of cabinets and adjacent wallboard. Inspect wallboard for water-damage and mold/mildew growth, repair/replace as necessary. Disinfect areas of microbial growth with an appropriate antimicrobial as needed.

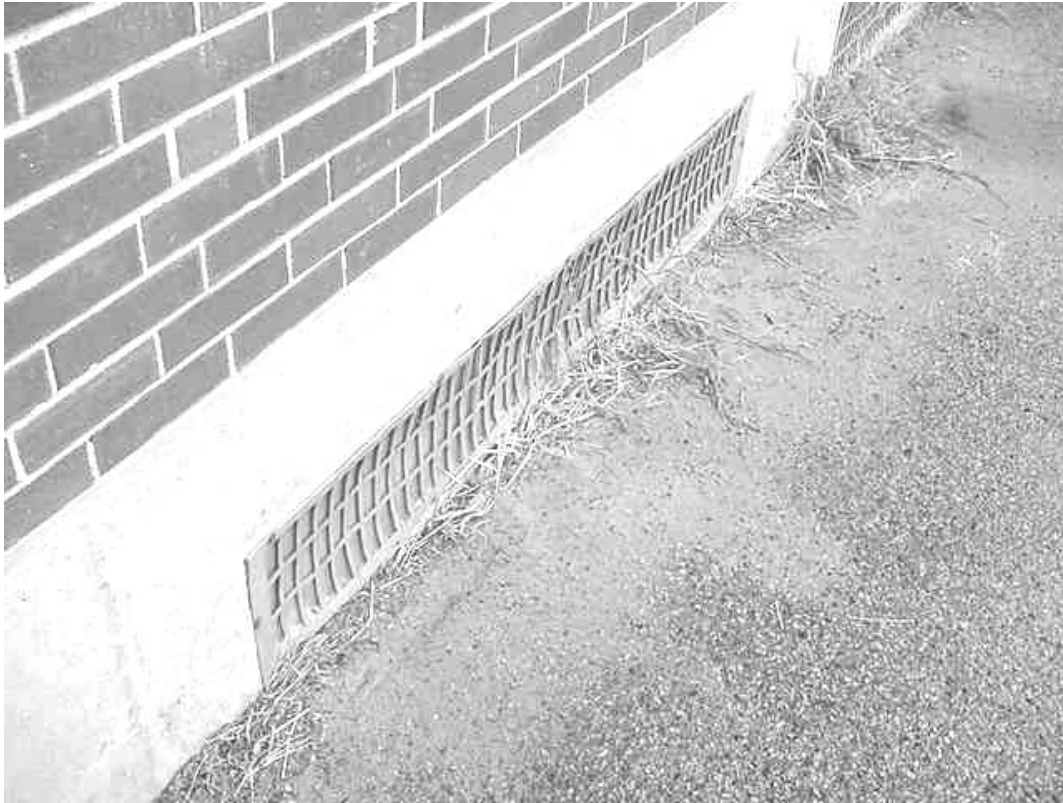
**Picture 5**

Along the perimeter of the building, shrubbery and other plants were noted in close proximity to univent fresh air intakes (see Pictures 5 & 6). Shrubby and plants can be a source of mold and pollen and should be placed and/or maintained to ensure that fresh air intakes remain clear of obstructions to prevent the entrainment of particulates into the building. Care should also be taken to ensure that fresh air intakes remain clear of snowdrifts during winter months. In addition, the growth of roots against the exterior walls, as well as spaces between the tarmac and exterior walls of the building, can bring moisture in contact with wall brick and eventually lead to cracks and/or fissures in the foundation below ground level. Over time, this process can undermine the integrity of the building envelope and provide a means of water entry into the building through capillary action through foundation concrete and masonry (Lstiburek J., & Brennan, T., 2001).

**Plant growth along Exterior Wall/Tarmac In Front of Univent Air Intake**

9. Inspect univent fresh air intakes along outside perimeter of building periodically; clear away shrubbery, plant growth and snowdrifts (during winter) as needed.

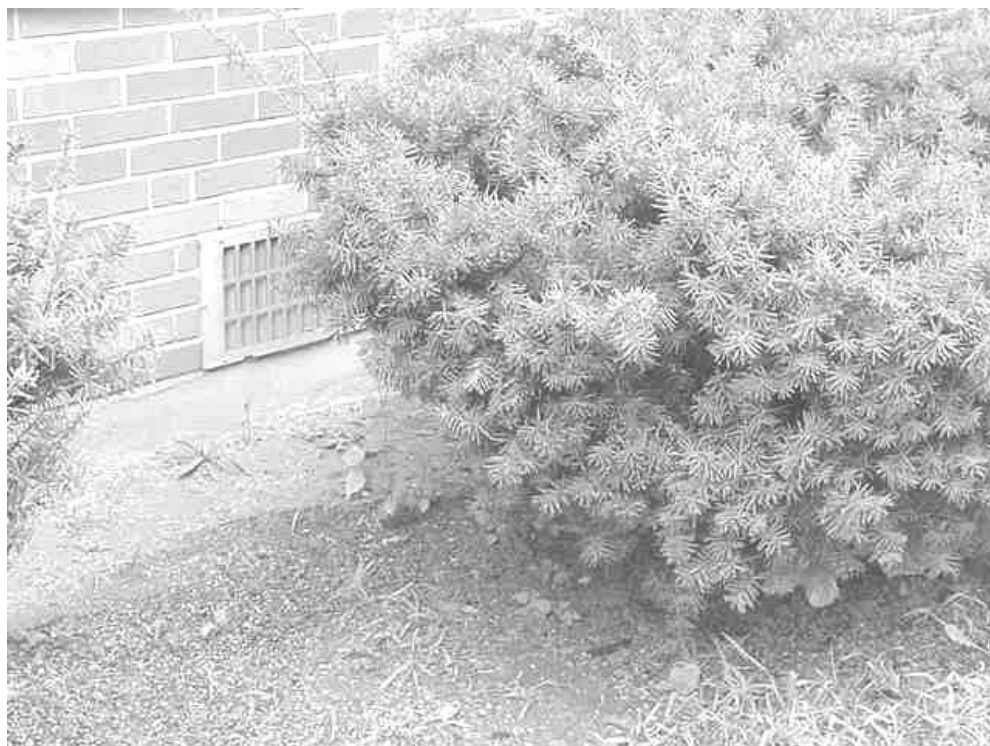
**Picture 6**

**Shrubbery Obstructing Univent Fresh Air Intake**

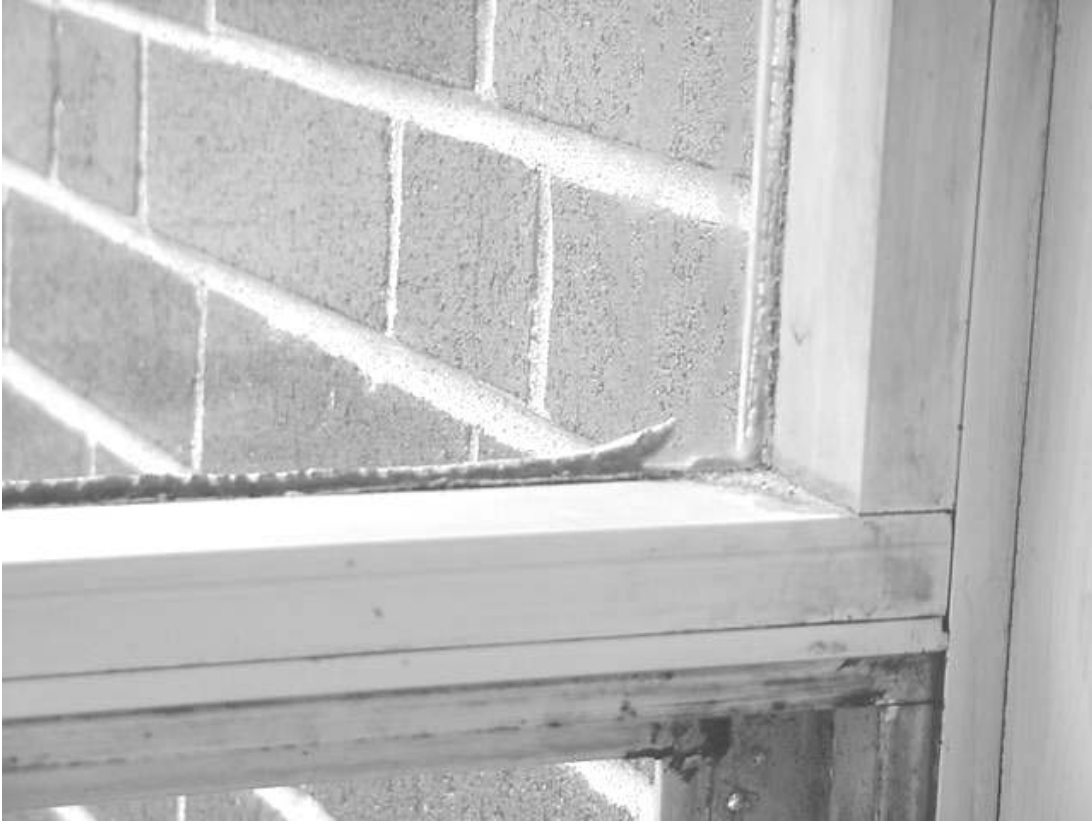
**Picture 7**

In a number of classrooms caulking around the interior and exterior windowpanes was crumbling, missing or damaged (see Picture 7). Repairs of window leaks are necessary to prevent water penetration. Repeated water damage can result in mold colonization of window frames, curtains and items stored on or near windowsills.

**Missing/Damaged Window Caulking**

7. Clean accumulated leaves and debris from fresh air intake pits.
8. Continue with plans to replace windows. If not replaced, repair missing or damaged window caulking building-wide to prevent water penetration and drafts through window frames.

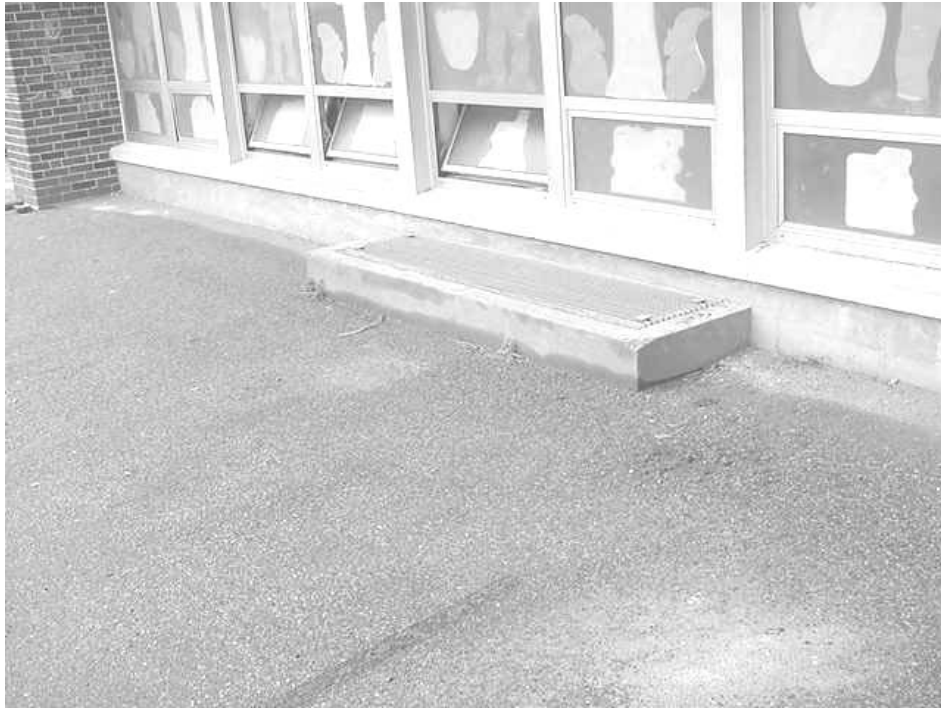
**Picture 8**

Univent fresh air intakes for some ground floor classrooms are located within subterranean, cement-walled pits (see Picture 8). An accumulation of leaves and debris was noted in these pits (see Picture 9). Wet leaves and trash can provide a medium for mold growth & odors that can be entrained into the building by the air handling equipment.

**Subterranean Pit Containing Univent Fresh Air Intake**

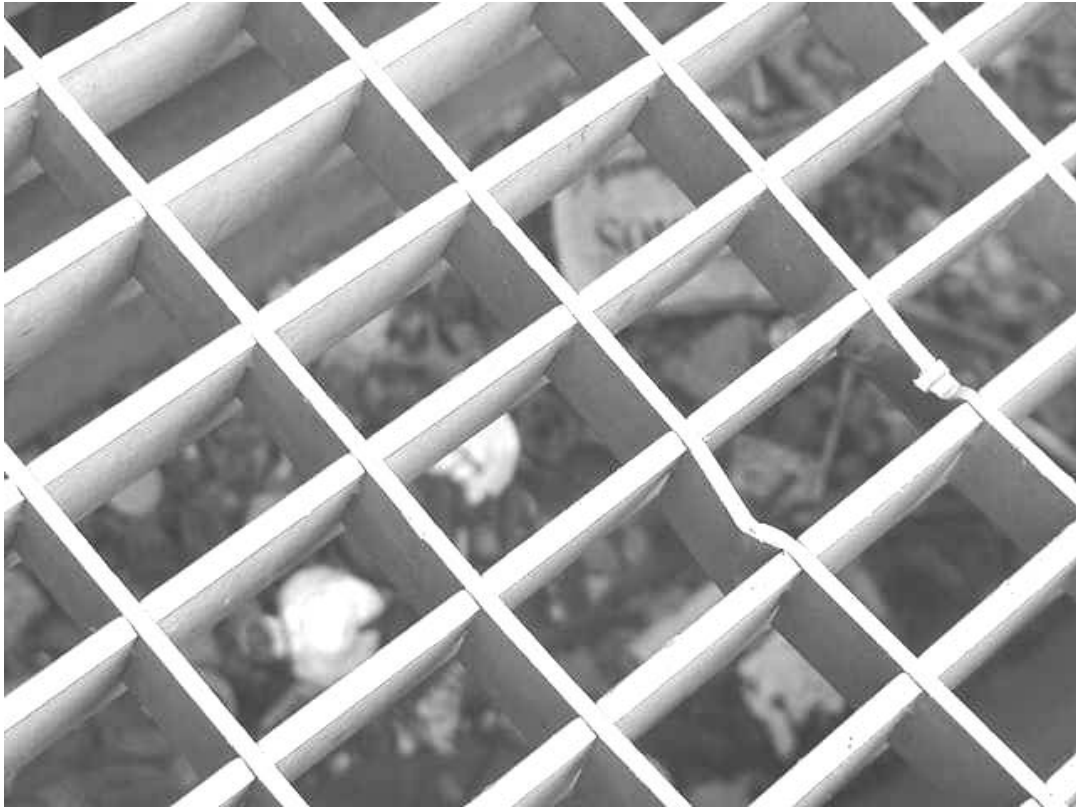
**Picture 9**

**Accumulated Leaves and Debris in Subterranean Pit Depicted in Picture 8**

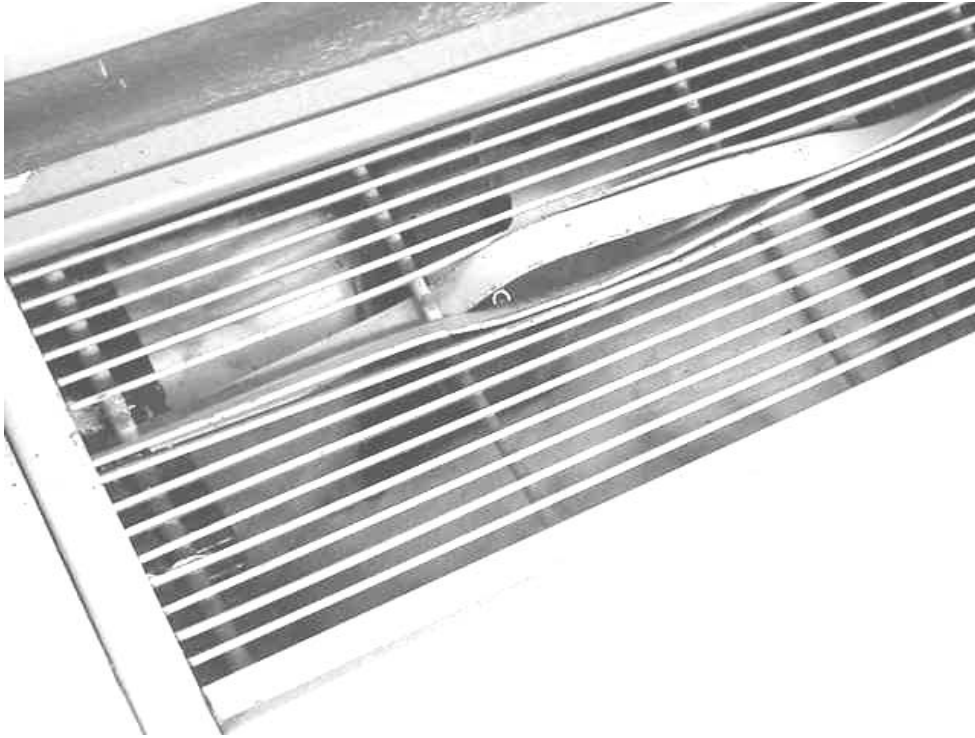
**Picture 10**

Several conditions that can potentially affect indoor air quality were also identified. Exposed fiberglass insulation was noted in the interior of the univent in classroom 108 (see Picture 10). The presence of exposed fiberglass insulation inside the univent air diffuser coupled with air movement provides the opportunity for particulates to become airborne. Also of note was the amount of materials stored in some areas. In many classrooms and common areas items were seen piled on windowsills, tabletops, counters, bookcases and desks (see Picture 11). The large amount of items stored provides a means for dusts, dirt and other potential respiratory irritants to accumulate. These stored items (e.g., papers, folders, boxes, etc.) also make it difficult for custodial staff to clean. Household dust and fiberglass insulation can become easily aerosolized and serve as a source of eye and respiratory irritation. In addition, fiberglass insulation material can also serve as a source of skin irritation to sensitive individuals.

**Exposed Fiberglass Insulation in Univent Interior (Air Diffuser)**

11. Remove or encapsulate damaged/exposed fiberglass in classroom 108 univent.
12. Relocate or consider reducing the amount of materials stored in classrooms to allow for more thorough cleaning of classrooms. Clean items regularly with a wet cloth or sponge to prevent excessive dust build-up.

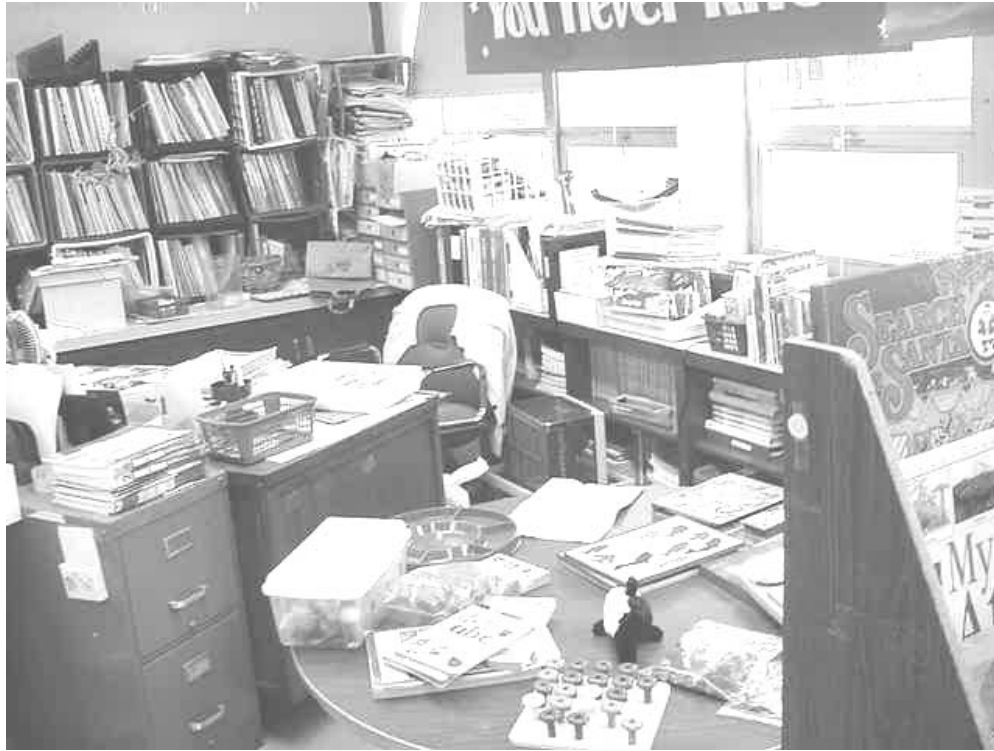
**Picture 11**

**Items in Classroom Covering Flat Surfaces Making Dust Control Difficult**

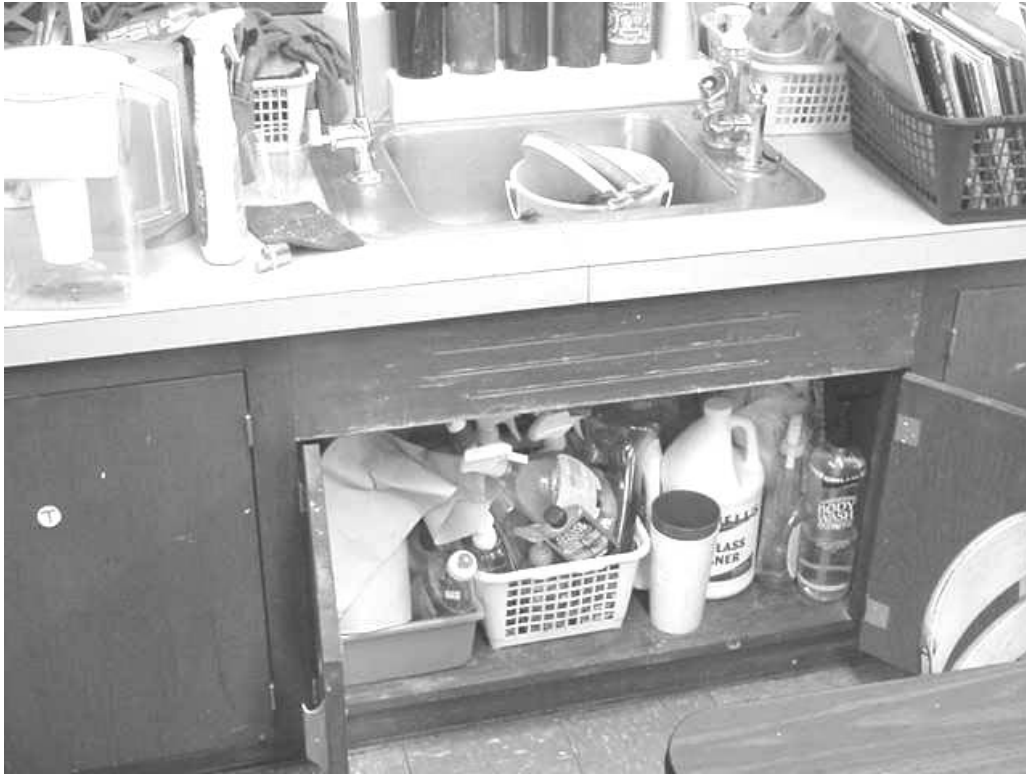
**Picture 12**

Cleaning products, unlabelled spray bottles and flammable materials were found on countertops and underneath sinks in a number of classrooms. Many of the sinks had cabinet doors open or were missing doors entirely (see Picture 12), allowing easy student access. Cleaning products and flammables contain chemicals, which can be irritating to the eyes, nose and throat. These materials should be stored properly and kept out of reach of students. In addition, these materials should be clearly labeled or stored in their original containers.

**Cleaning Products Stored On/Beneath Classroom Sink**

10. Store chemicals and cleaning products properly and out of the reach of students. Ensure products are properly labeled in the event of an emergency for identification purposes.

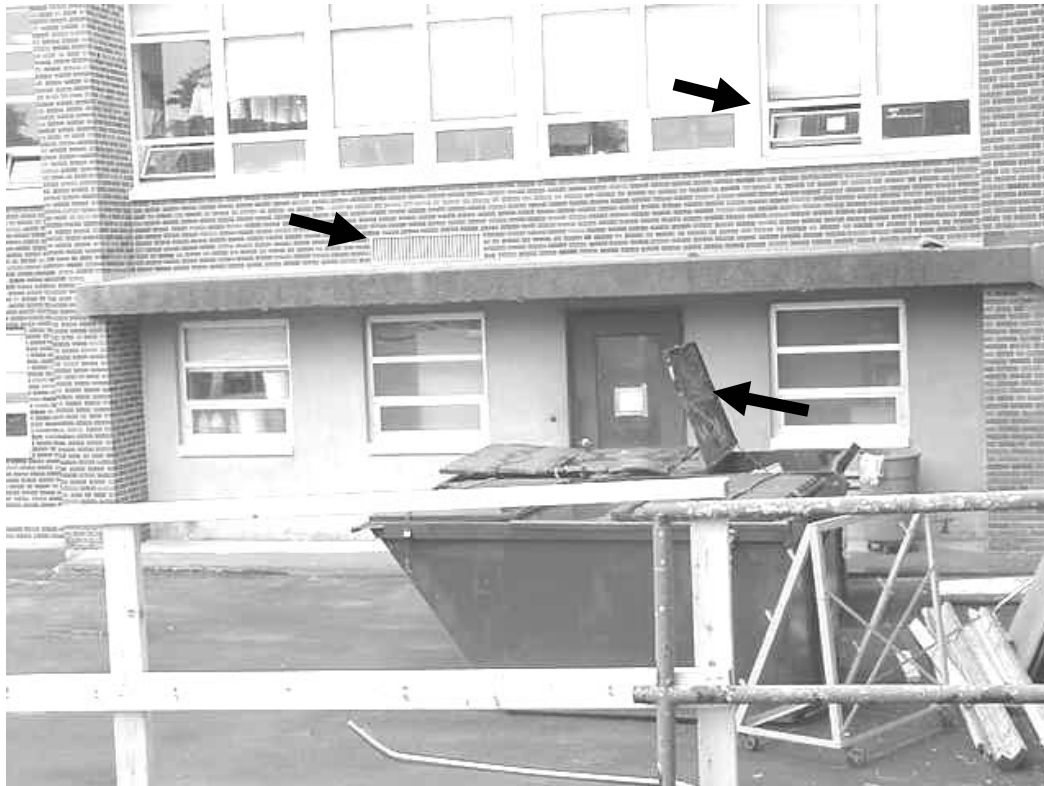
**Picture 13**

The school's dumpster is located behind the building. Although no reports of trash odors were reported, the close proximity of the dumpster to the building may

provide for nuisance odors to enter classrooms through the univent fresh air intake (see Picture 13) or by open windows during the spring and summer months.

**Proximity of Dumpster to Univent Fresh Air Intake and Open Window  
Note Open Access Panel to Dumpster**

13. Consider relocating the dumpster further away from the building. If not feasible, ensure access panels are closed to contain odors.
